DAN LAZAR

EASY FILL UP IN POSTERIOR COMPOSITE RESTORATIONS

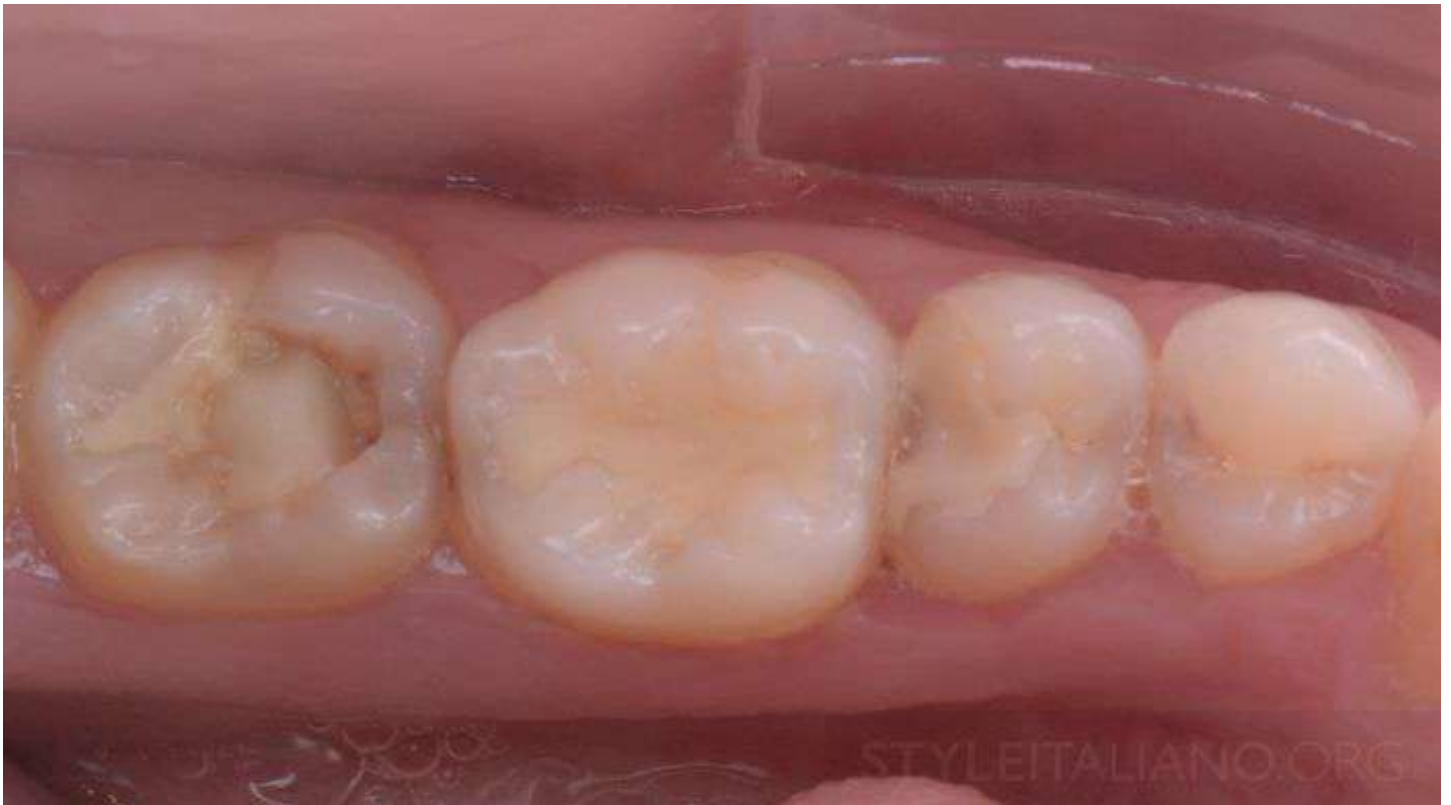
Img. 1 - In this case, the used material (Fill-up!, Coltene) is pretty easy and fast to manage; it was combined with an easily polishable composite material (Brilliant Ever glow, Coltene). For all big cavities the Fill up!

was used deep in one layer - a dual curing bulk composite and the last layer of material was Brilliant - a photo cured composite material.

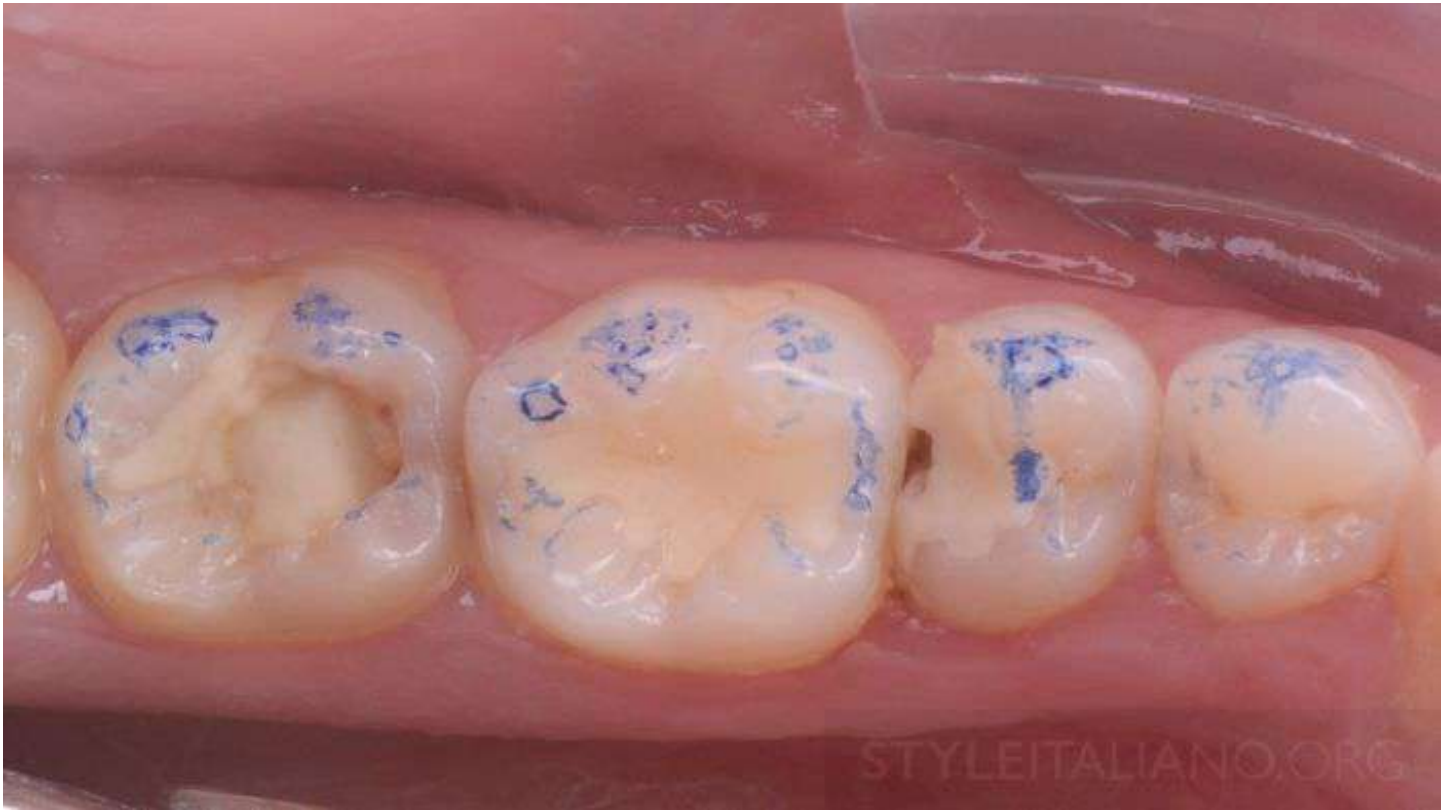
Img. 2 - Occlusal check before isolation and cavity preparation.

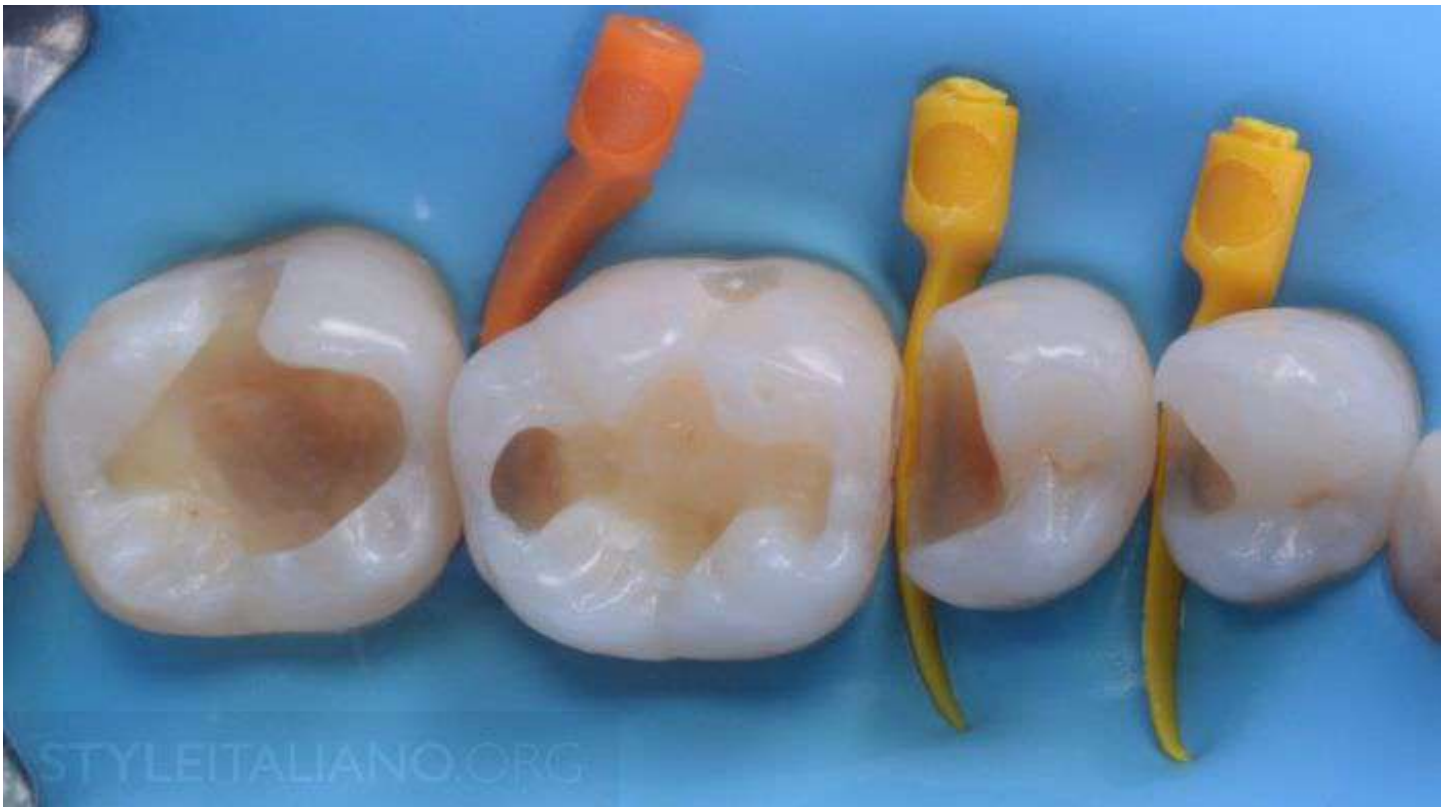
Img. 3 - In all proximal cavities, prewedge were used to protect the proximal rubber dam and to facilitate the finishing procedure of the proximal walls.

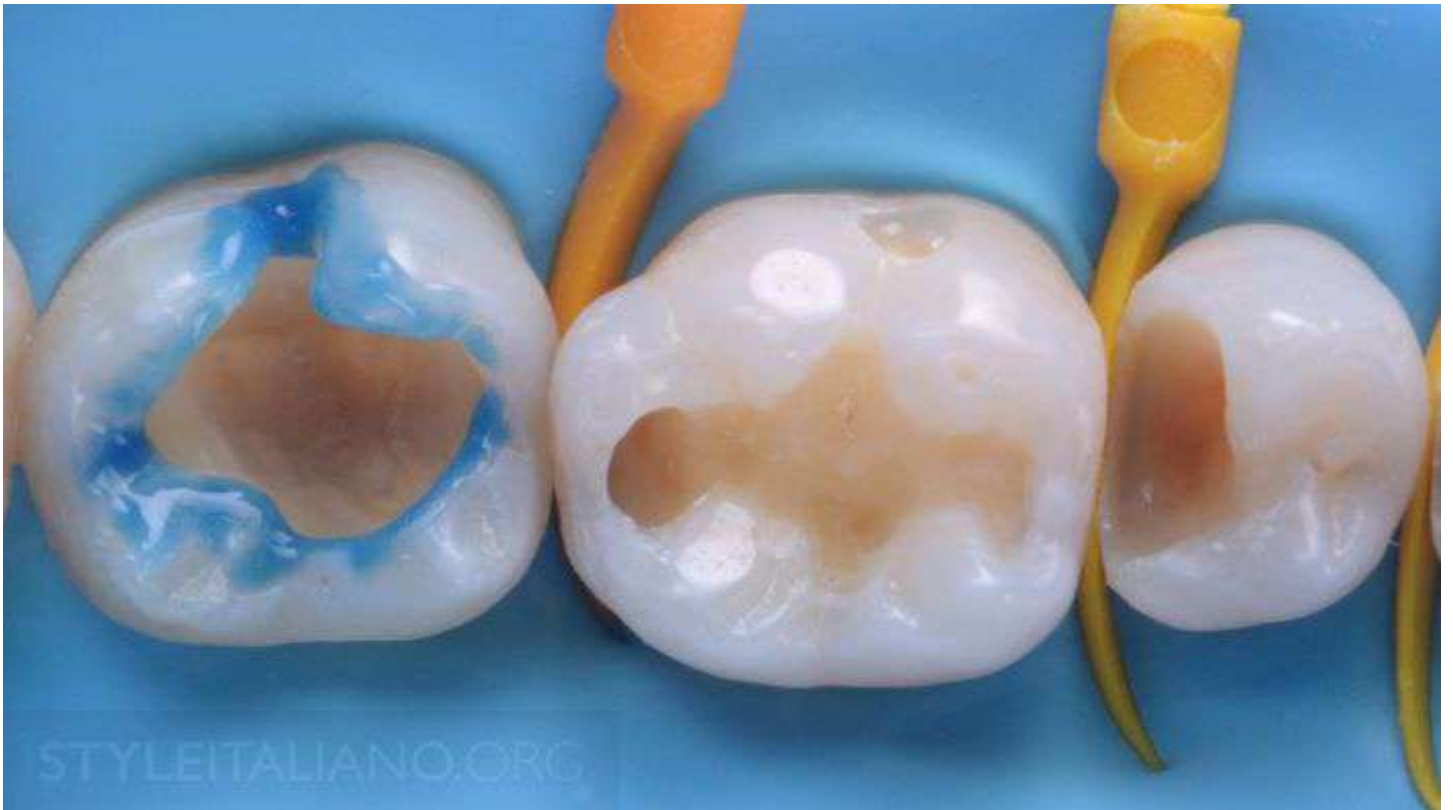
Img. 4 - In all cavities, selective etching technique was used; phosphoric acid was applied for 30 seconds. As an adhesive, One Coat 7 Universal (Coltene) was used.

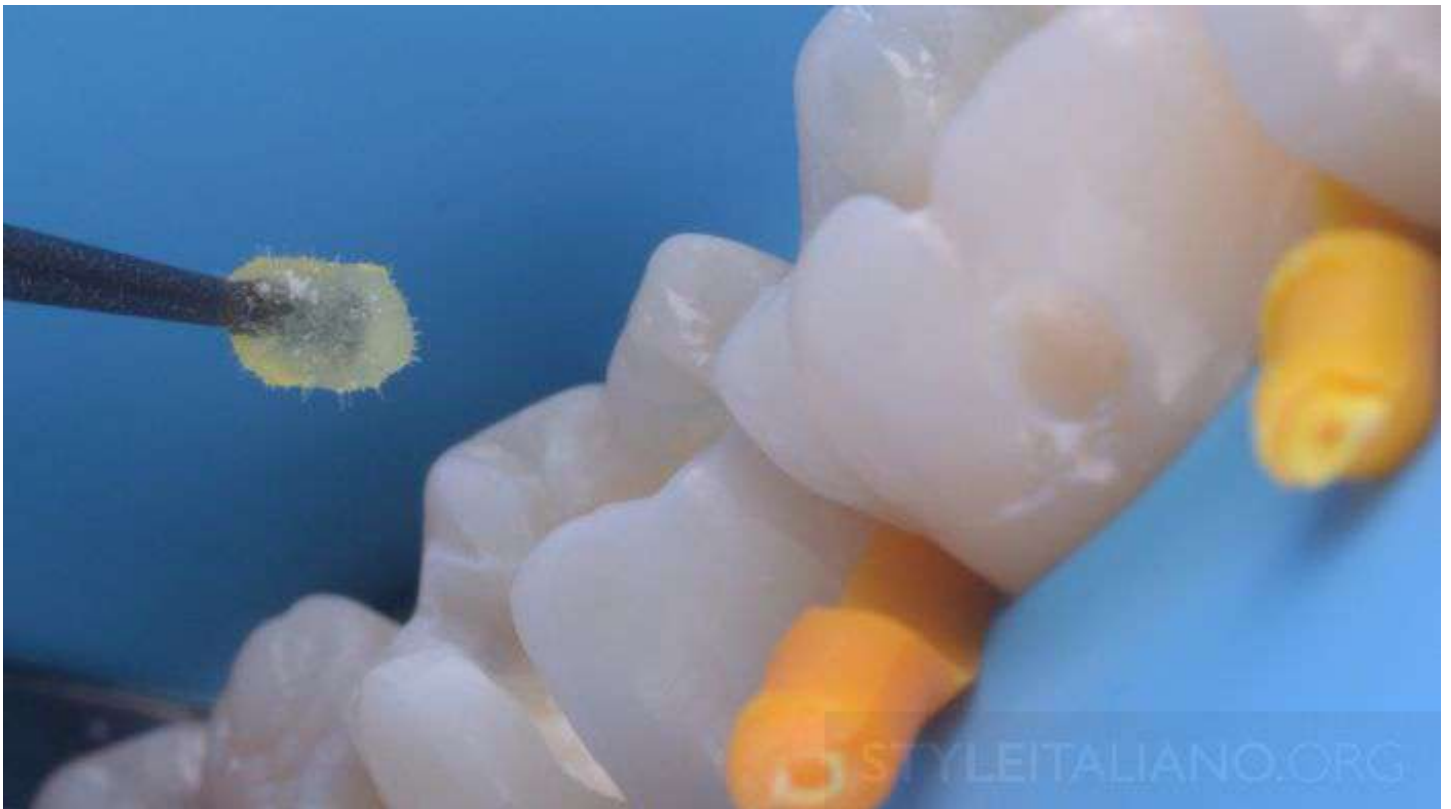
Img. 6 - The self etching adhesive was applied over the enamel and the dentin for 20 seconds. The adhesive excess was removed using aspiration from the unit and the blow of the air. When the adhesive is not moving anymore under the pressure of the air, then we know that the thickness is close to the optimal. Then we light cure for at least 10 seconds (minimum 800mW/cm²).

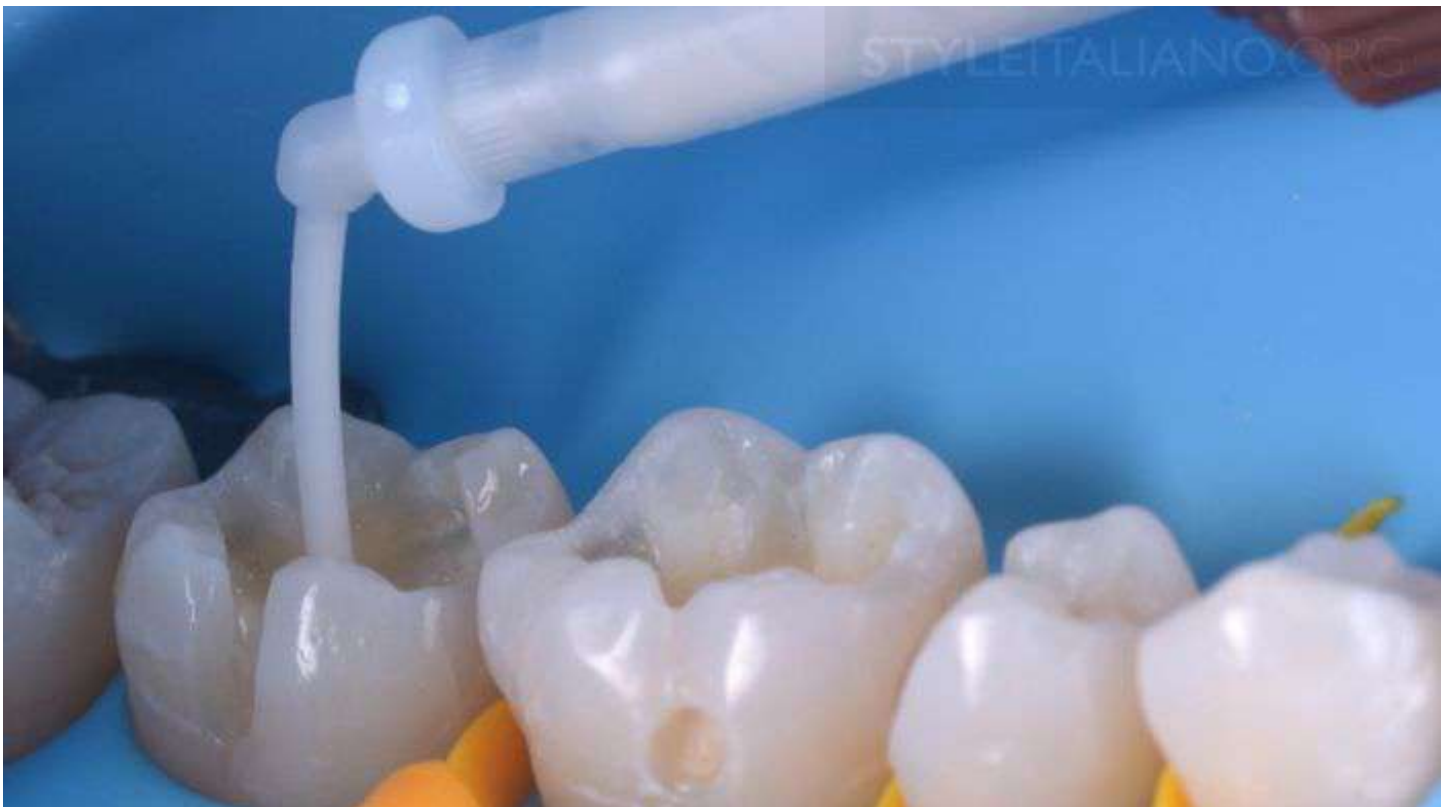
Img. 7 - The dual cured bulk composite was then used to fill the bottom part of the cavity, leaving space for the last layer of the material. After the placement of the material we should leave it to self cure and after

that to use the light curing lamp.

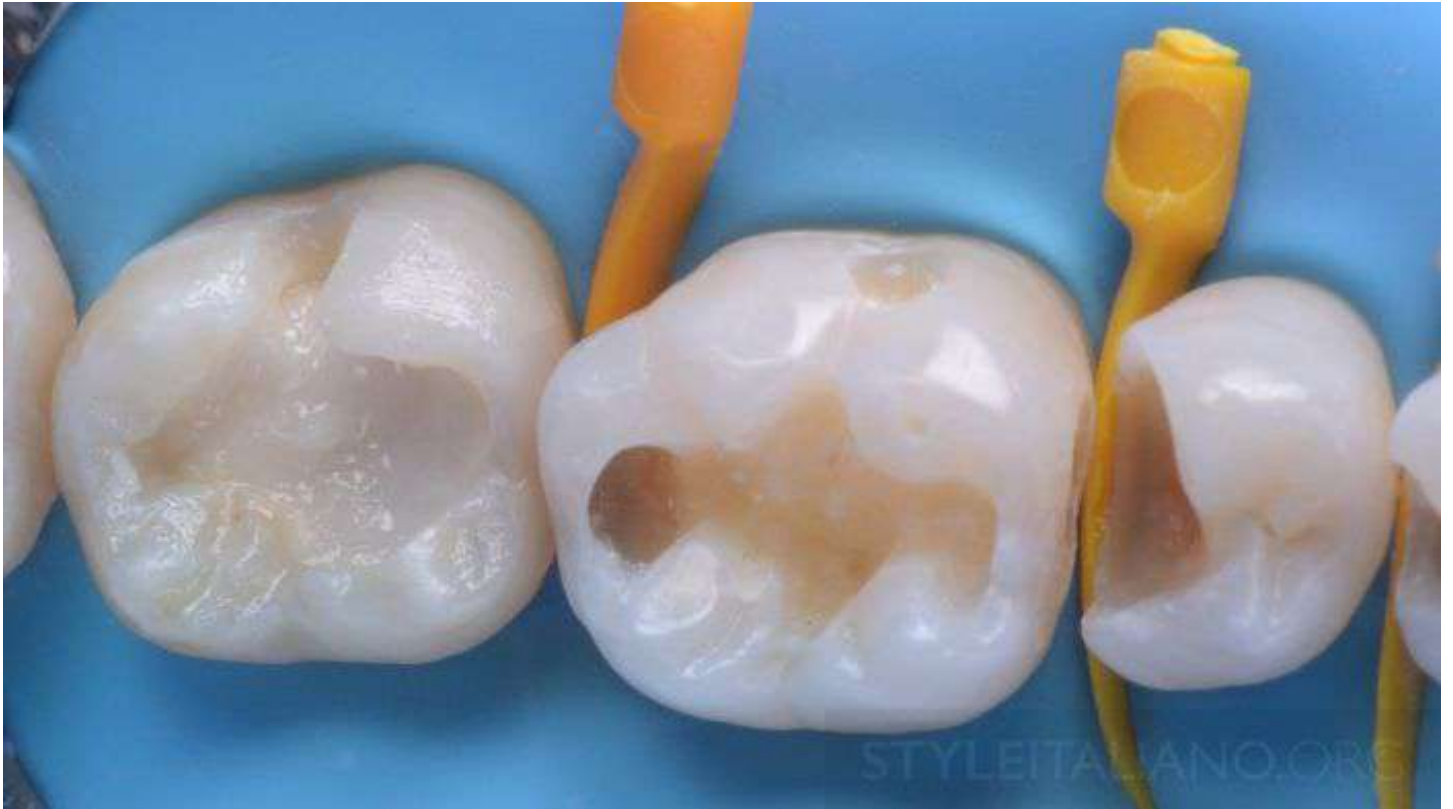
Img. 8 - The aspect of the dual cured bulk material after light curing. To be sure that there is not any dual cured material on the outline of the cavity, an adhesive tip can be used to remove the excess before the curing of the material.

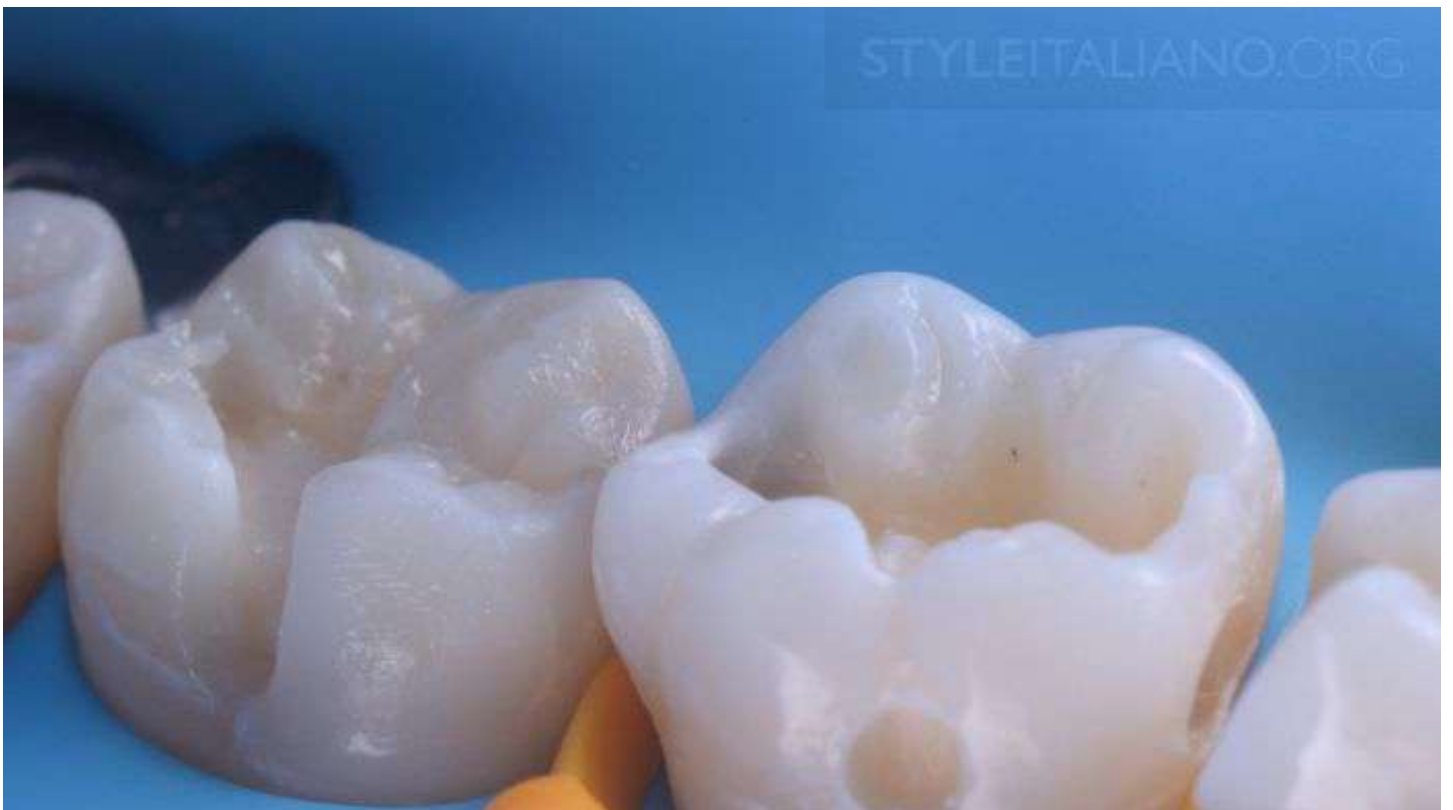
Img. 9 - The final layer of the composite material were A2/B2 Brilliant Ever Glow by Coltene.

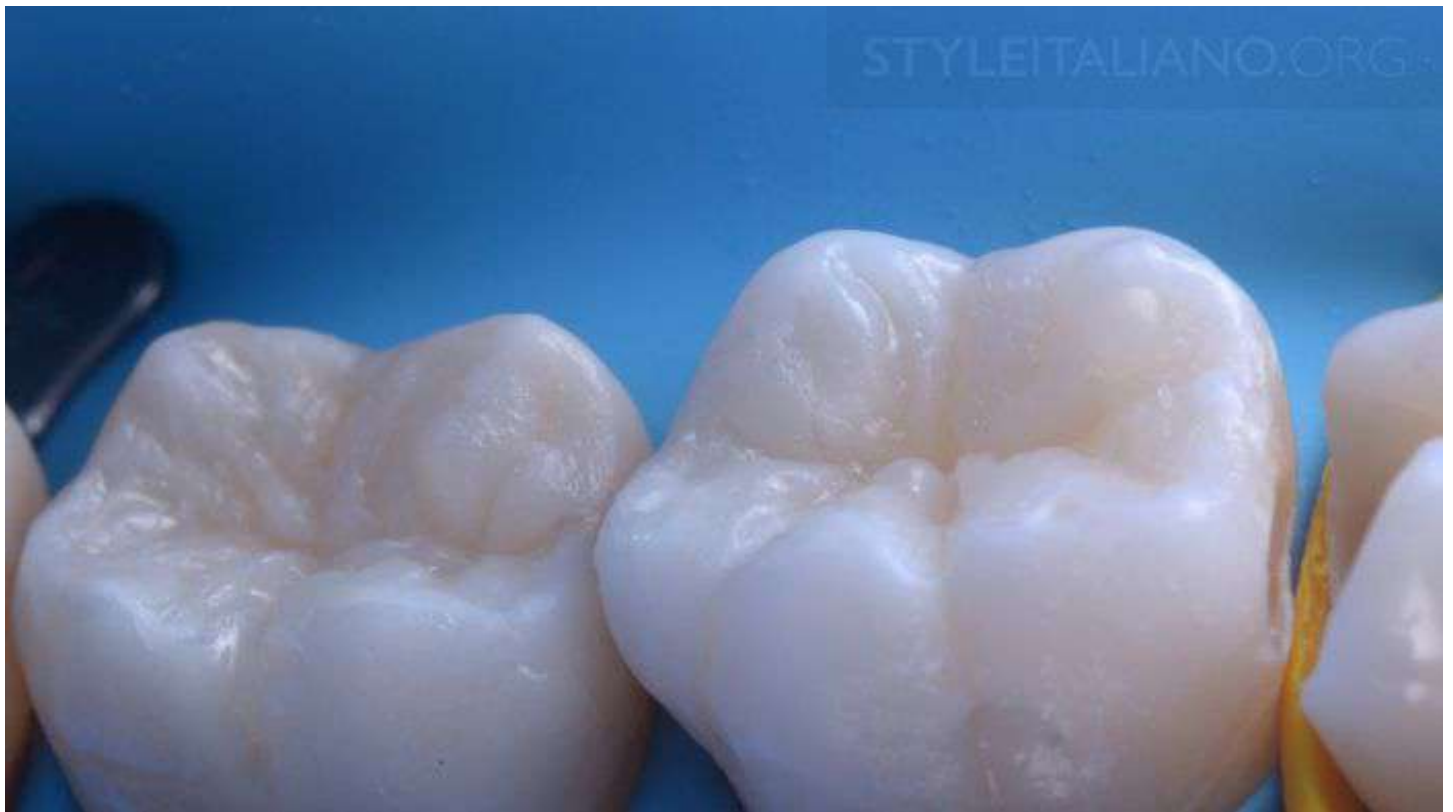
Img. 10 - On the first molar, because the cavity was superficial, only the photo cured material was used. The image shows the aspect after the modelling of the material.

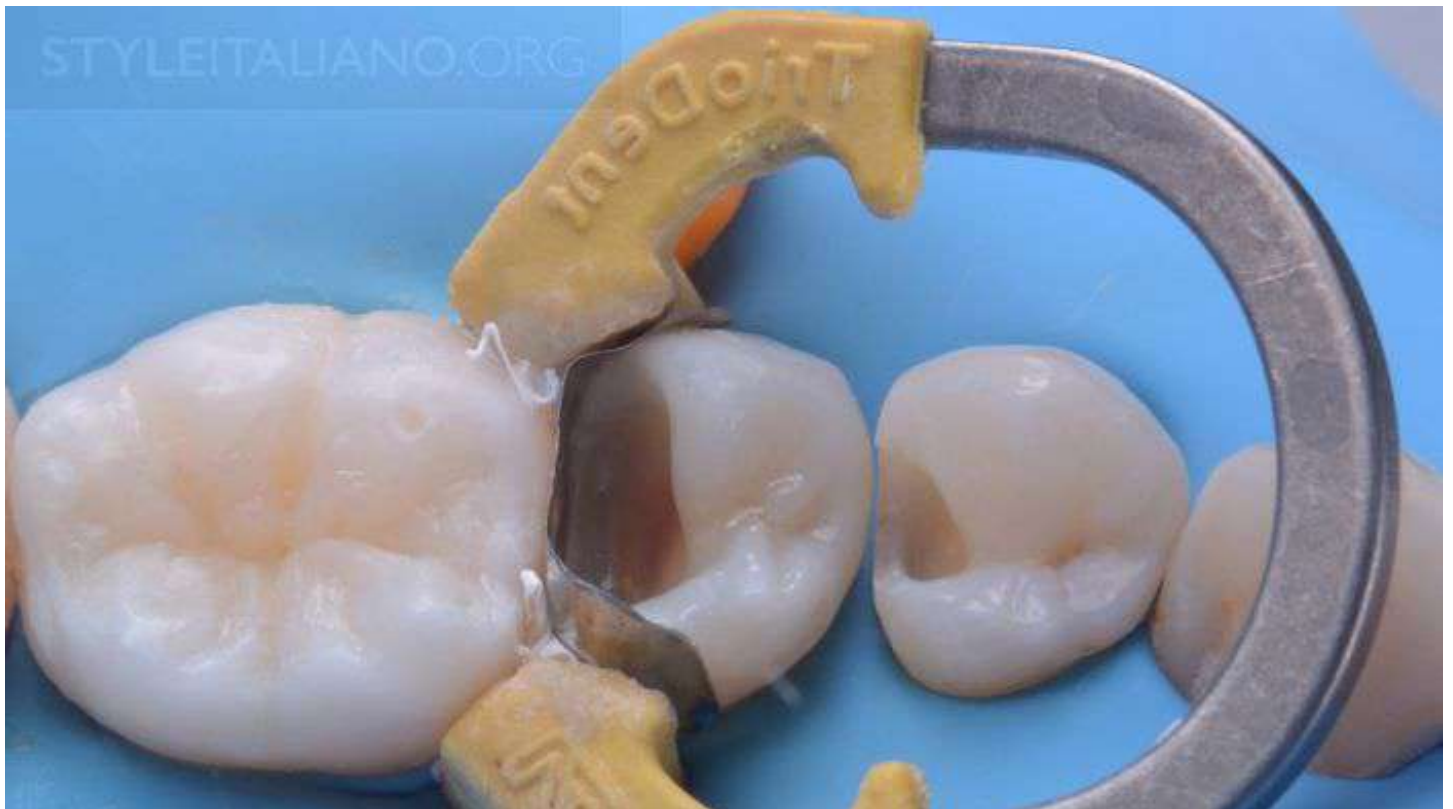
Img. 11 - Sectorial matrix with teflon tape and V ring were used to restore the proximal wall on the second premolar.

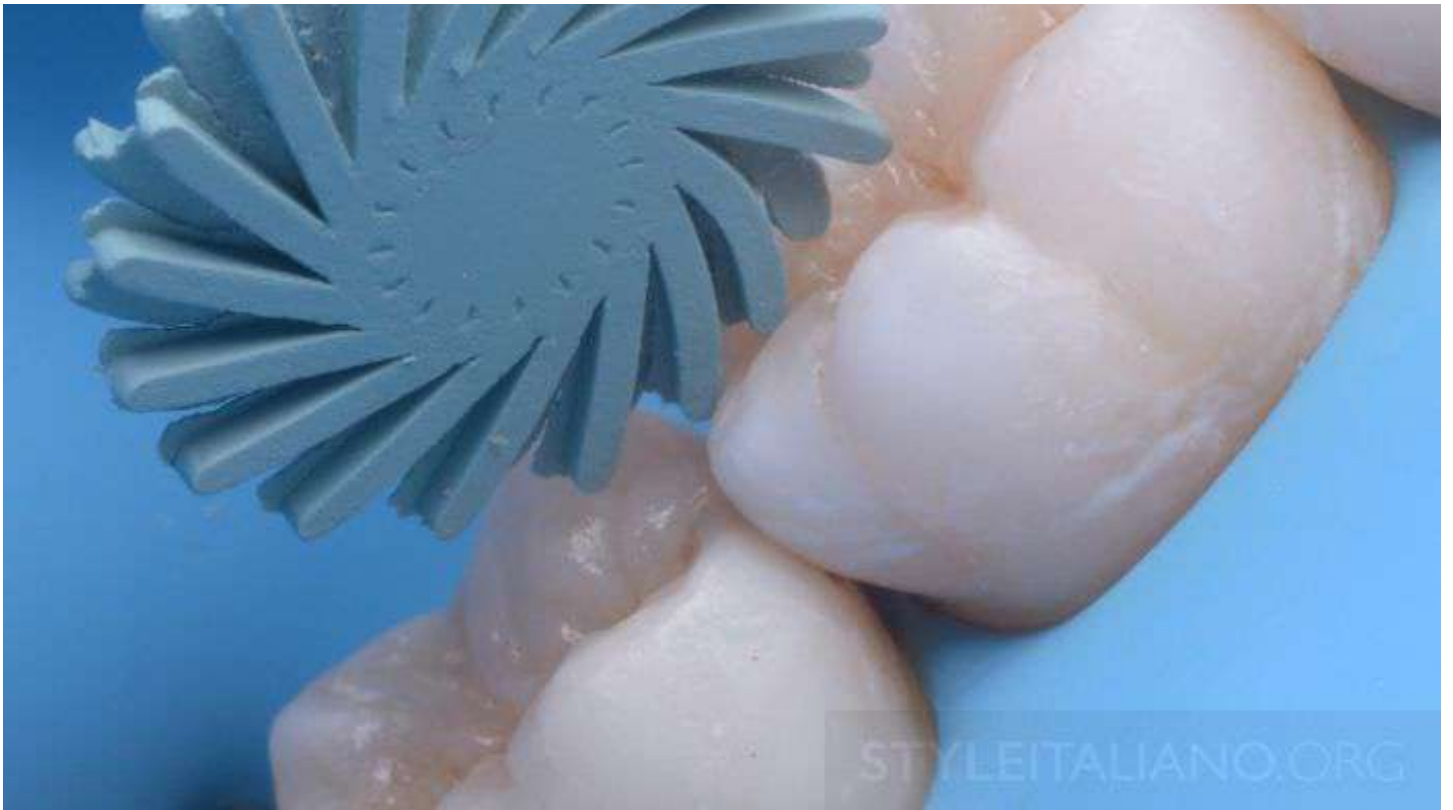
Img. 12 - Diotech Polishers by Coltene were used as a polisher system after the outline finishing of the restoration with Arkansas bur.

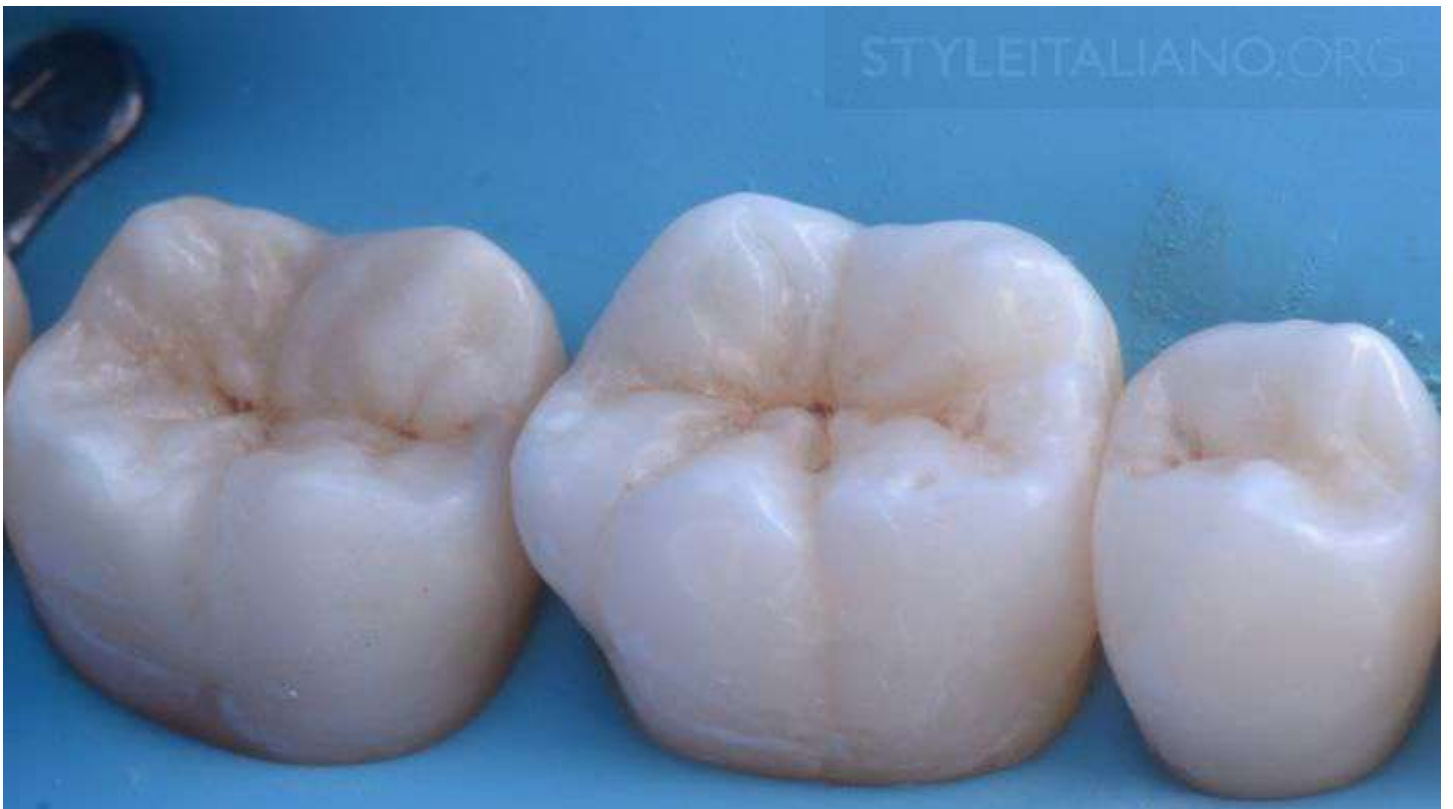
Img. 13 - Final aspect of the restorations after some brown stains were used (Empress Direct - Ivoclar).

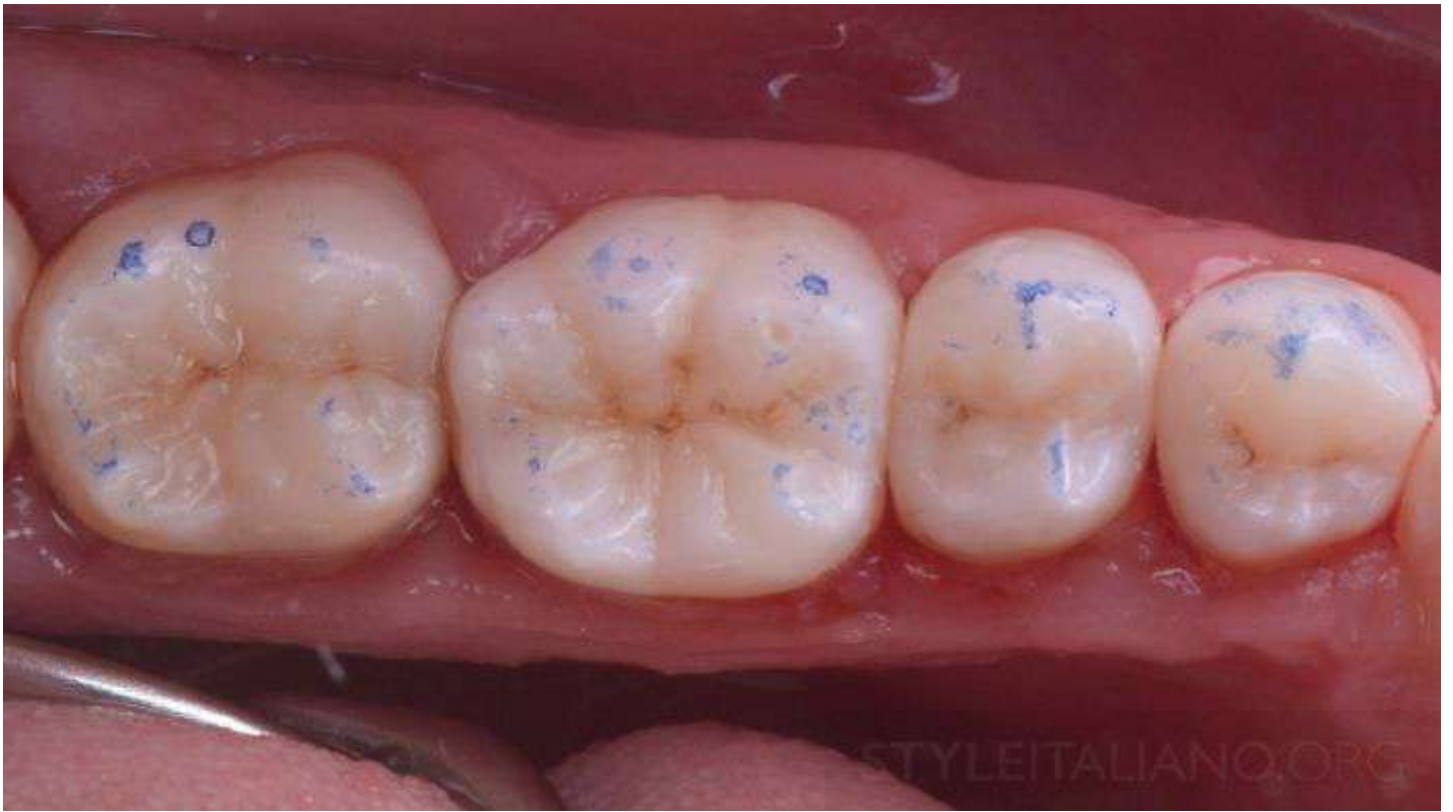
Img. 16 - Occlusal contacts after rubber dam removal.

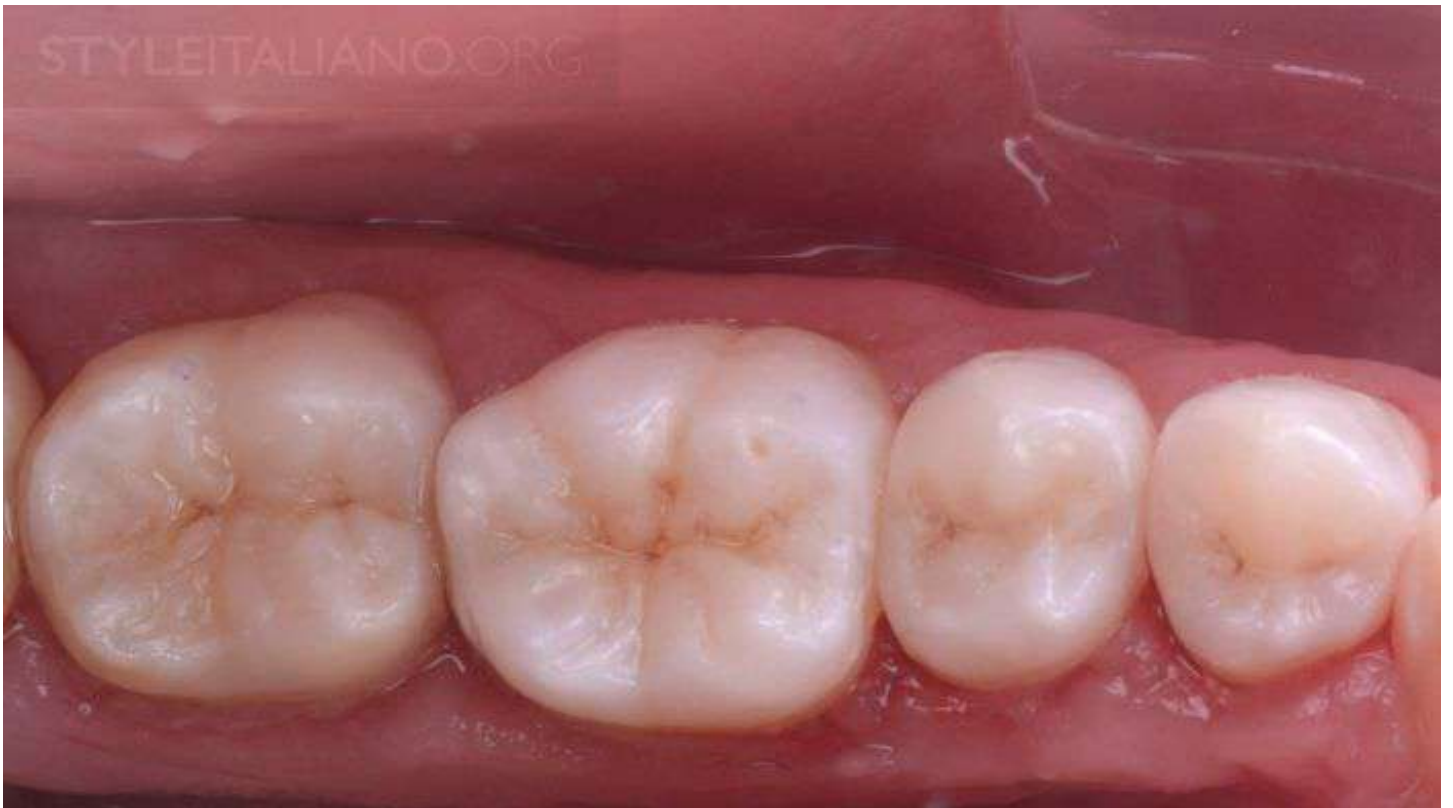
Img. 17 - Final aspects of the restorations after 2 hours and 23 minutes.

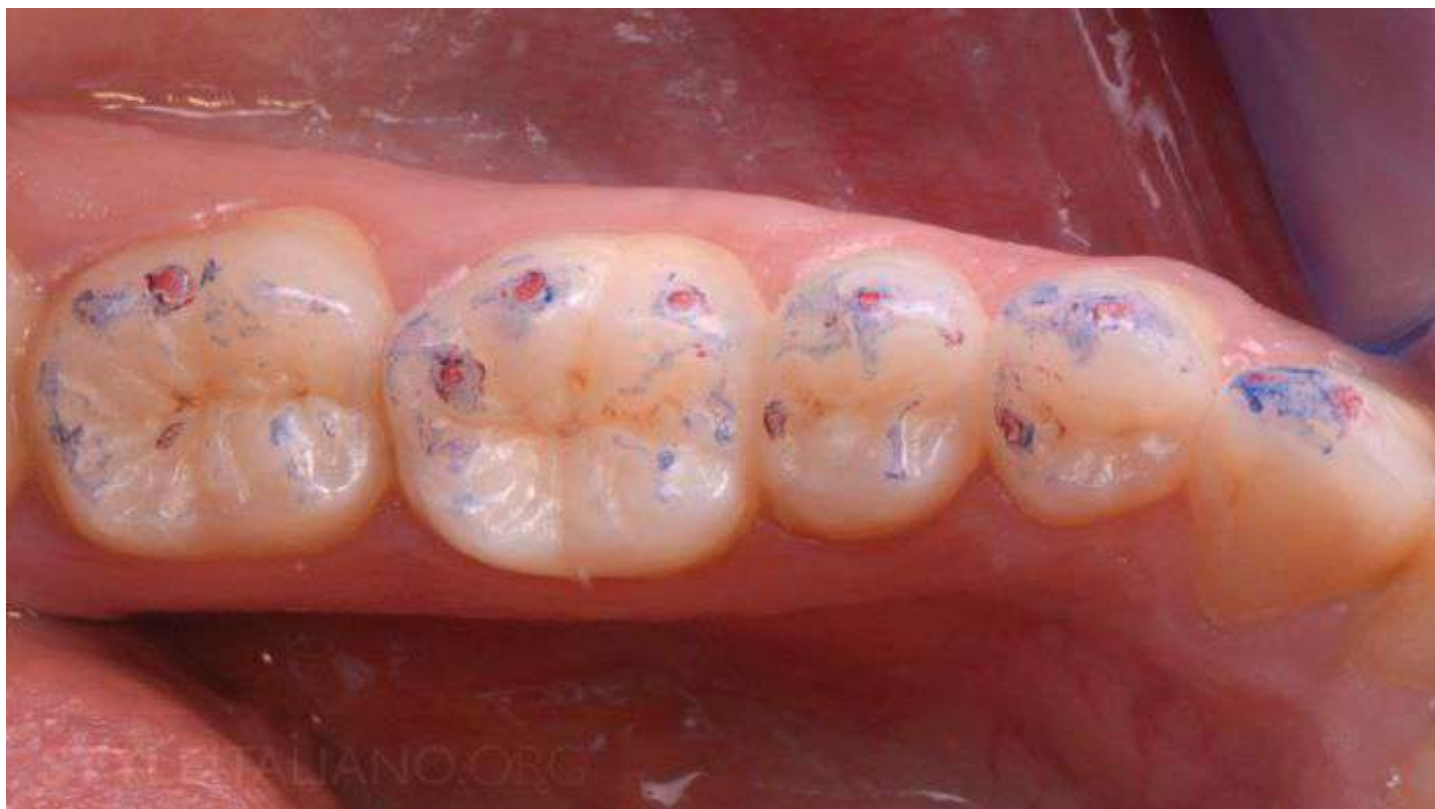
Img. 18 - 10 Months after restoration; static occlusal contacts marked with 40 (blue) and 8 (red) microns.
